Manhole Inspection Summary

Manhole # S37W1_018MH

Insp Date: **11/8/08 10:06 AM**

Location Address: **3540 S. Hanover St.**

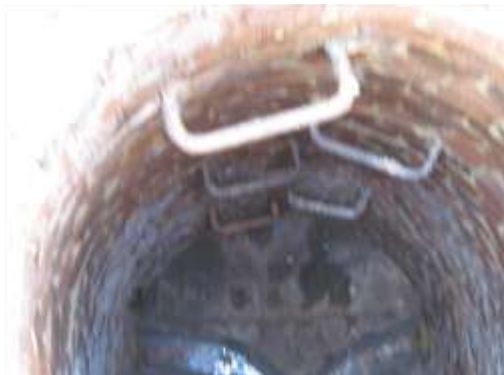
Steps

Count: **5** Missing: **0** ☐ Corroded

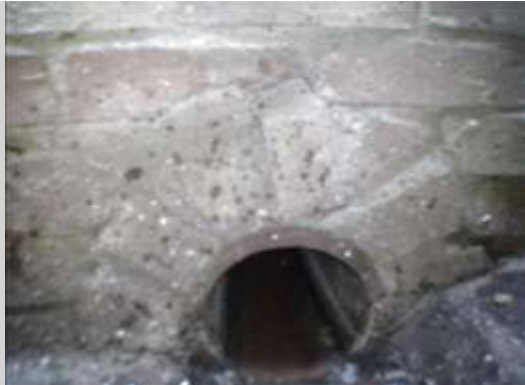
12 O'Clock Outflow

8 in. Circular Gravity Sewer
Pipe Out @ 12 O'Clock

Pipe Height: **10.8** (in.) Rod and Bar (Angled)
Pipe Material: **Clay** ☐ Pipe Lined
Invert Depth: **9.72** (ft.) Flow Characteristics: **Fast**
Deposits: ☒ None ☐ Mud ☐ Gravy ☐ Debris ☐ Grease
Silt Depth: **1** (in.) Deposits Extent: **Medium**
Infiltration: **None** Pipe Seal Cond: **Sound**

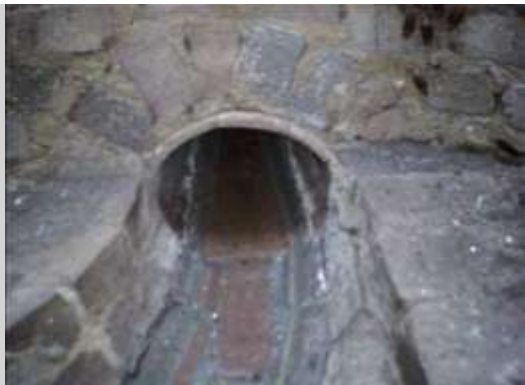
3 O'Clock Inflow

8 in. Circular Gravity Sewer
Pipe In @ 3 O'Clock

Pipe Height: **9.6** (in.) Rod and Bar (Angled)
Pipe Material: **Clay** ☐ Pipe Lined
Invert Depth: **9.56** (ft.) Flow Characteristics: **Fast**
Deposits: ☒ None ☐ Mud ☐ Gravy ☐ Debris ☐ Grease
Silt Depth: **1** (in.) Deposits Extent: **Medium**
Infiltration: **None** Pipe Seal Cond: **Sound**

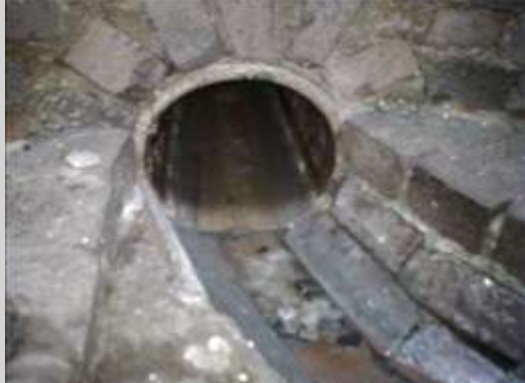
9 O'Clock Inflow

Deposits: ☐ None ☐ Mud ☒ ~~Sludge~~ **Debris** ☐ Grease

Silt Depth: **1** (in.) Deposits Extent: **Medium**

Connects To: **Stub connection / abandoned**
